RECONNAISSANCE OBSERVATION FROM MAY 12 CHINA EARTHQUAKE

Chu-Chieh Jay LIN*

Associate Research Fellow, National Center for Research on Earthquake Engineering, Taipei, Taiwan*

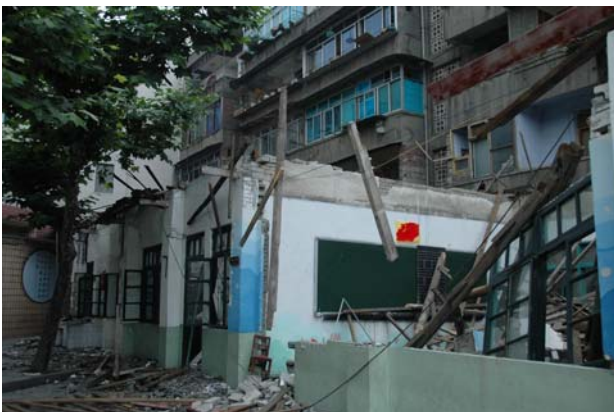
Fig. 2 The collapsed masonry classrooms

A significant number of injuries and casualties were associated with the total collapse of the school, commercial and residential buildings. Figures 2-6 show the collapsed buildings of elementary schools as well as failure and damage of commercial-residential buildings at Dujiangyan. Due to lack of ductile structural elements in the URM and

masonry buildings to resist the seismic lateral force, the structural collapse and its consequences lead to human life losses and injuries are inevitable during a severe earthquake.

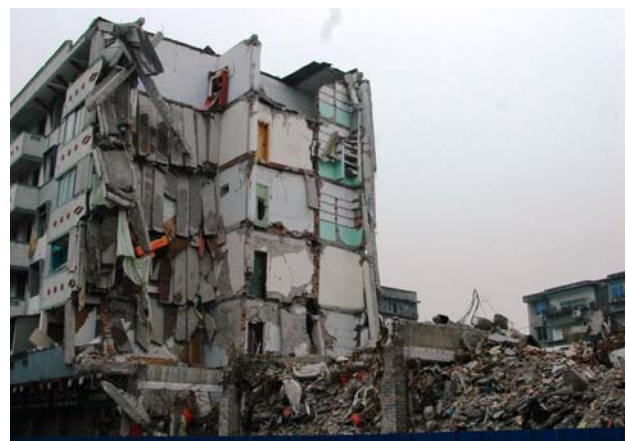
Fig. 4 The collapsed residential buildings (URM)

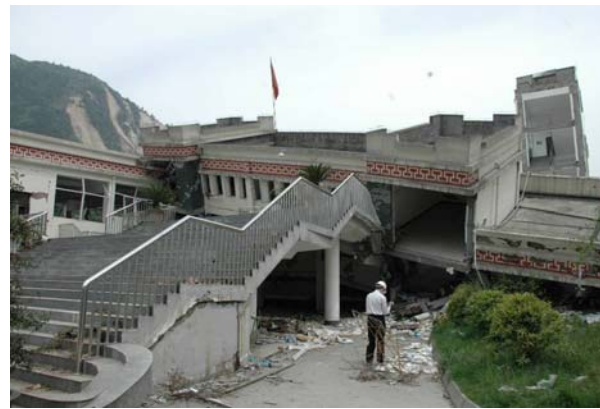
Fig. 9 The collapsed RC school building

Even the engineered RC buildings were experienced severe damage or collapse because of the strong shaking of the earthquake when near the epicenter; figures 7-10 show such damages in Hsuanko High School at Yingxiu (Wenchuan).

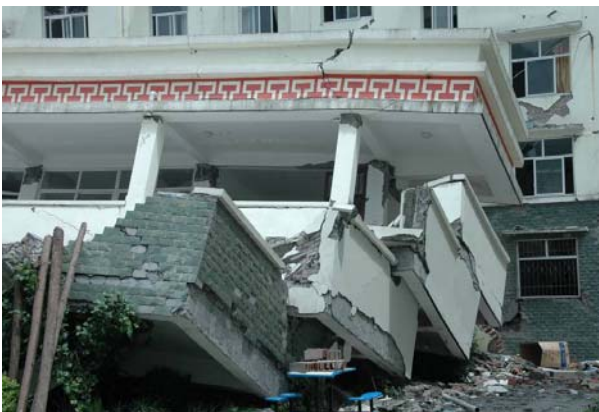
Fig. 7 The collapsed RC school building

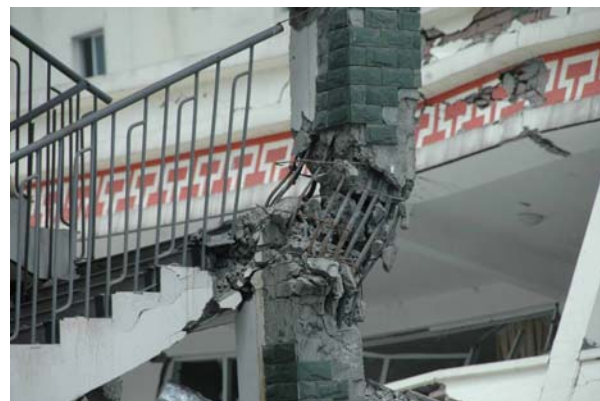
Fig. 10 The close-up of a damaged RC column

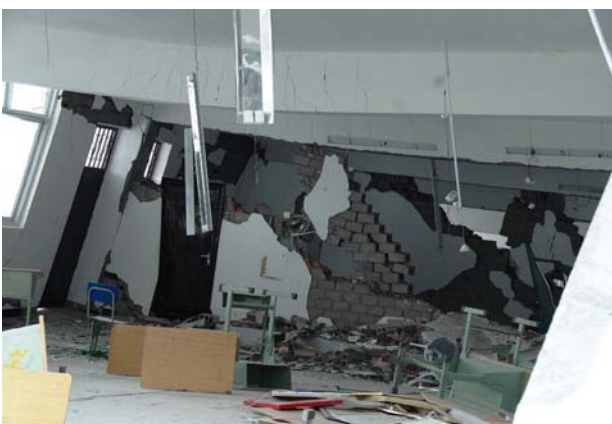
Fig. 8 The damaged classroom

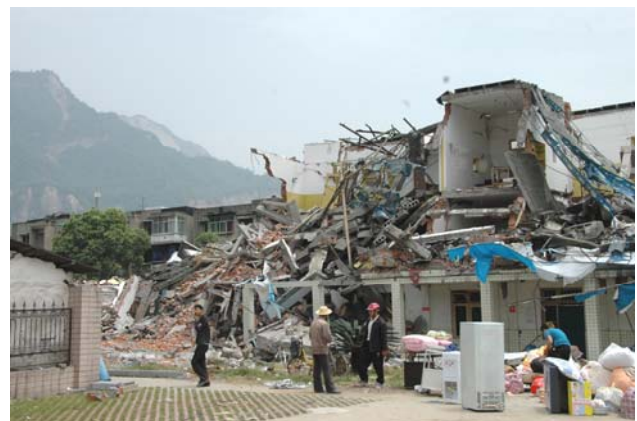
Fig. 11 The collapsed dormitory of a hospital

The hospitals suffered damages of different degrees from moderate to severe so they were not able to operate with normal function to rescue the injured and save lives right after this natural catastrophe. Figure 11 shows the collapsed buildings of a hospital at Hanwang. Figures 12-14 show hospitals with no

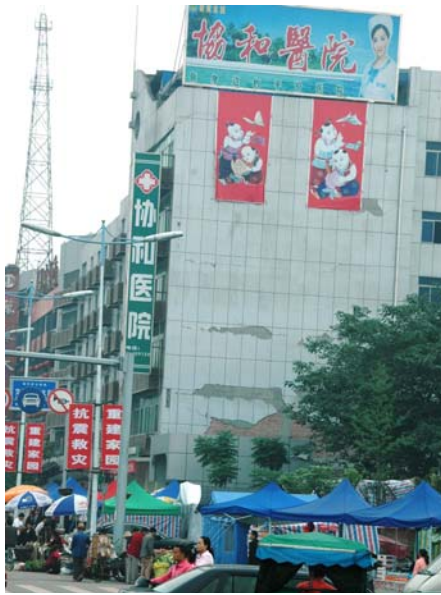
service due to partial damages or lack of water and power.

Fig. 12 The hospital suffered medium damages

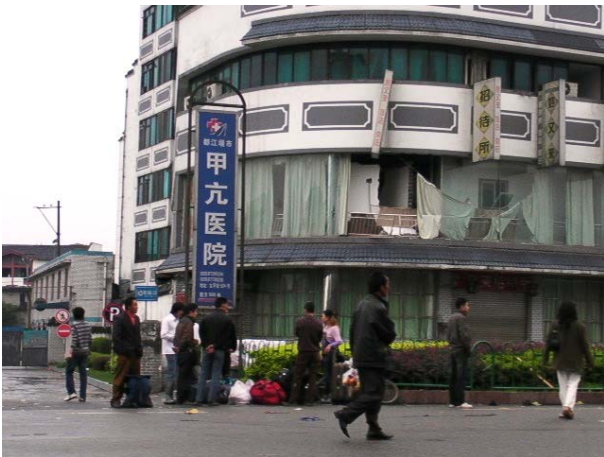
Fig. 13 The structural damages of a hospital

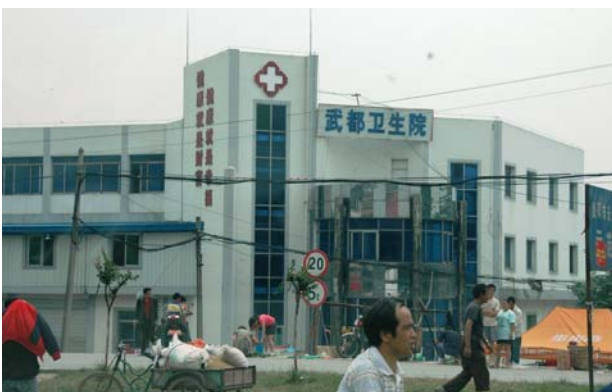
Fig. 14 The hospital is out of service

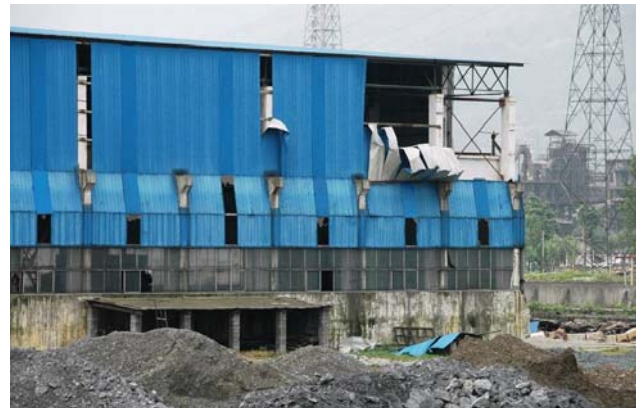
Most of the factories suffered structural or non-structural damages in this earthquake. The operations were almost shut down due to these damages as well as lack of electricity. Figures 15-17 show the damaged factories. However, there is a premix concrete factory in the affected area remains operation after the earthquake and provide enormous help to the community (figure 18).

Fig. 15 The damaged factory

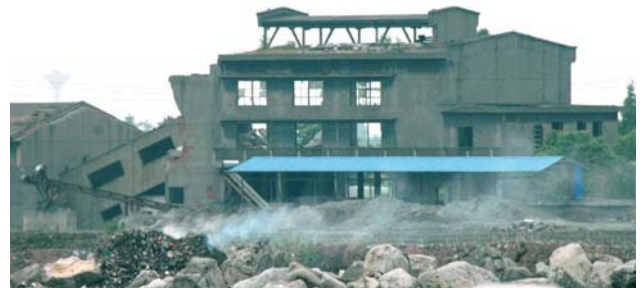
Fig. 16 The collapsed factory

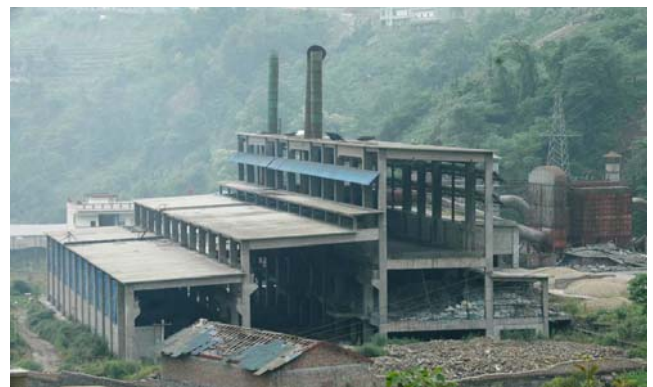
Fig. 17 The mess in the factory

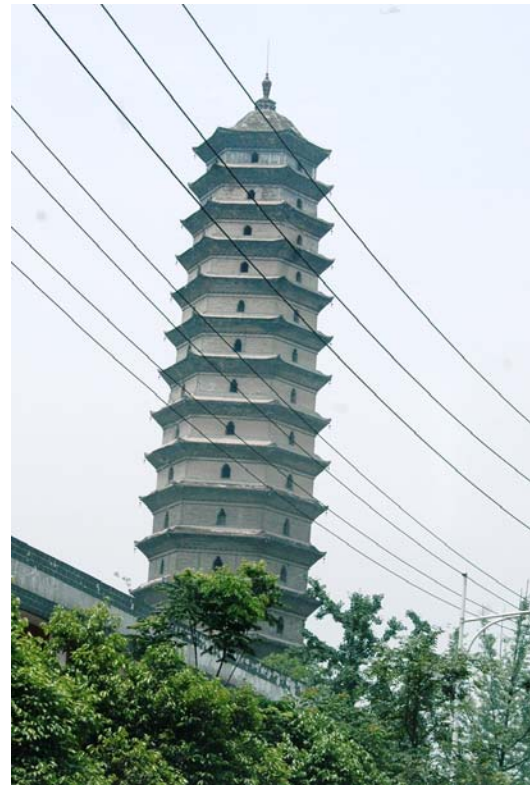
More amazingly, there are a lot of undamaged high-rise structures found in the earthquake affected region. Figures 19-22 show such structures including towers, pagoda and chimneys. They may have a lower natural frequency than dominant frequency content of the seismic waveforms, which may have helped survive high accelerations.

Fig. 20 The high-rise pagoda

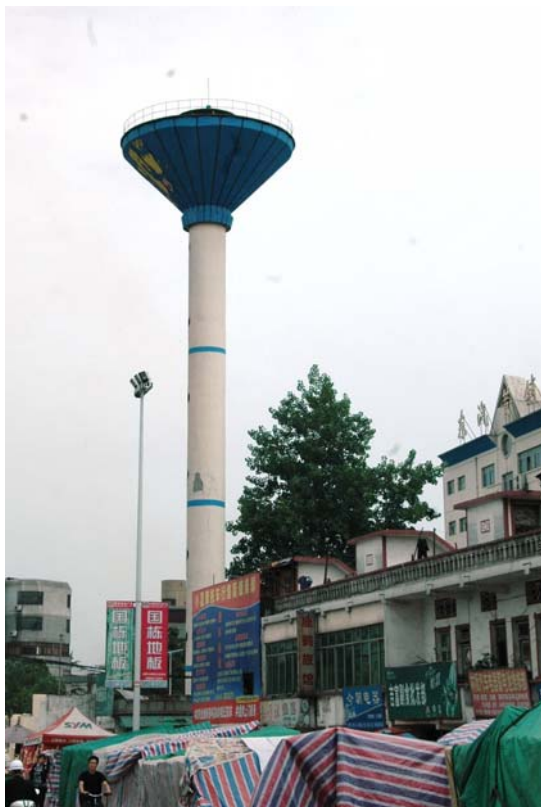
Fig. 19 The water tower is still standing

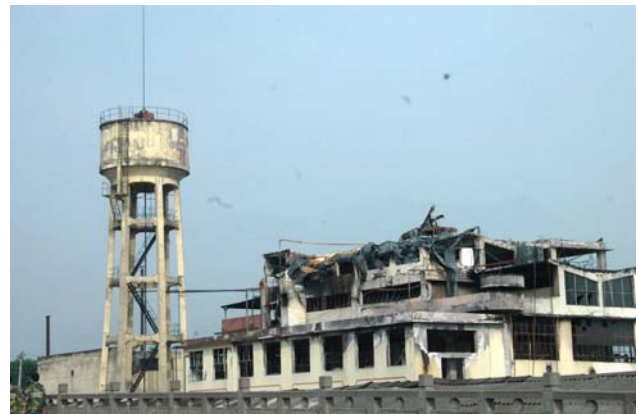
Fig. 21 Another undamaged water tower

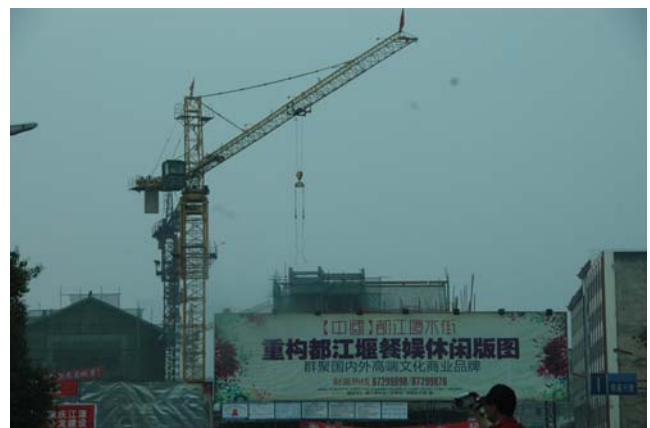
Fig. 22 The crane tower is still in operation

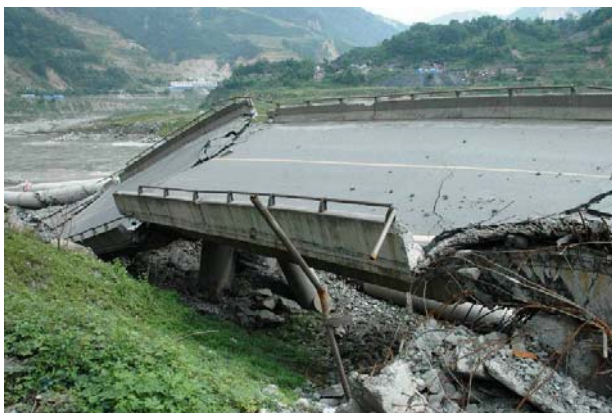
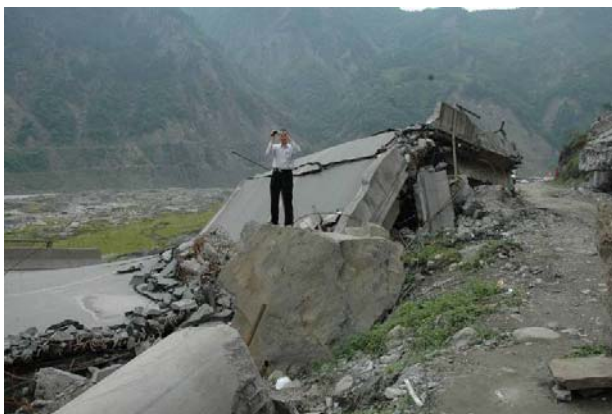
Fig. 23 The collapsed decks of Baihwa bridge

Fig. 24 The collapsed Baihwa bridge

Baihwa Bridge is a reinforced concrete (RC) slab beam continuous bridge supported by twin column pier with cap beam on expansion joint. It is a 500 m long, 30 m height viaduct and plays a critical role on the route from Dujiangyan to Wenchuan when

opened to traffic since 2004. There are about 50 m long bridge slab collapsed on the location of the turning section after earthquake as shown in figures 23 and 24. Due to the safety reason, the un-collapsed part of Baihwa Bridge is demolished using explosives to reduce the threat to the emergency path underneath the bridge.

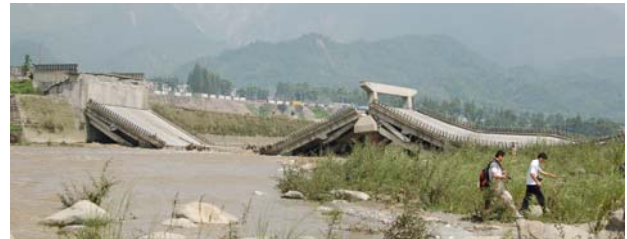
Fig. 25 The collapsed spans of Xiaoyudong bridge

Fig. 26 Fault rupture went through the embankment of Xiaoyudong bridge

Fig. 27 The fractured element of Xiaoyudong bridge

Xiaoyudong Bridge was a four-span RC arch bridge

as shown in figures 25-27. The fault rupture and the strong motion of the earthquake caused the collapses of two spans and severely damaged the rest of the bridge. The destruction of the embankment, abutment and the barrier, the buckling of the arch, as well as the shifting of the road surface are all observed to witness the enormous pressure of the strong earthquake motion.

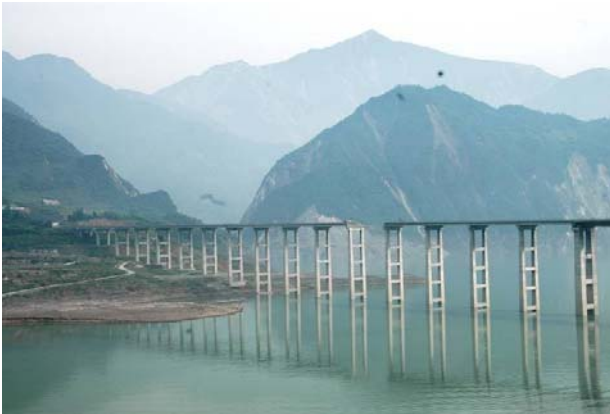
Fig. 28 The falling span of Miaotzuping bridge

As shown in figure 28, Miaotzuping Bridge is located at the Zipingpu dam water reservoir area near Dujiangyan. This beautiful bridge is 1436 m long with 108 m height composed of main bridge (long span continuous box girder type) and 19 approaches (T-girder simple supported with continuous deck). Though the main construction of the bridge is completed but it is not opened to traffic yet since the unfinished facilities. There are spans shifting on both longitudinal and horizontal directions causing the damages of shear keys on both sides. Furthermore, the earthquake caused one of the T-girder approaches collapsed due to possible insufficient support length of cap beam for falling prevention (narrow seat).

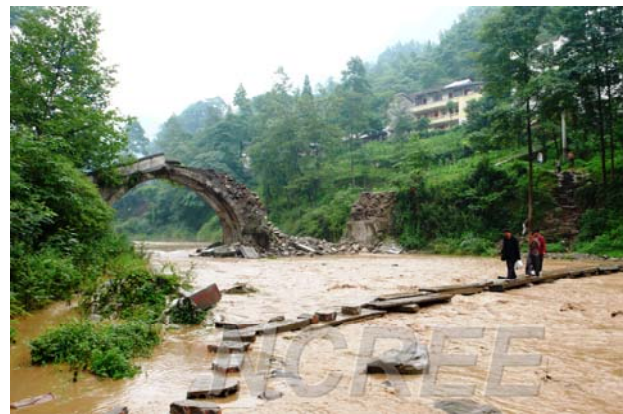
Figure 29 shows a destroyed ancient masonry arch bridge at Bailu. In addition, the rest of the bridges on

Fig. 29 The destroyed arch bridge in Bailu

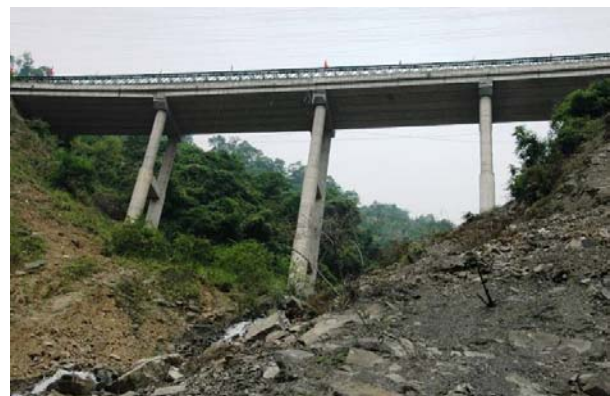
National Highway 213 were all suffered different degree of damage such as shifting, cracks on bridge support, and destructions of side stoppers (shear keys), as shown in figure 30. Since the bridges play very important roles on transportation and it is critical for emergency rescue and response tasks, the slightly damaged bridges were temporary retrofitted by Bailey bridge with speed and weight limit (figure 31).

Fig. 30 The damaged bridge in Highway 213

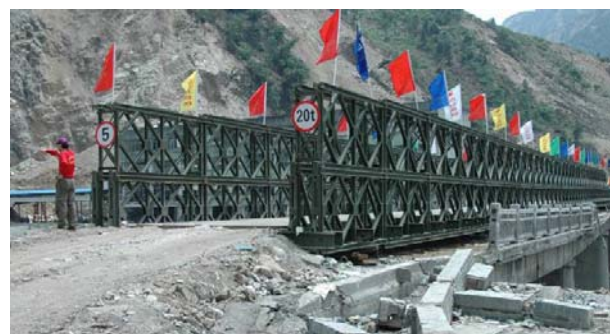
Fig. 31 The speed and weight limits on the Baileys

Also shown in figure 31, the bridges at Mianzhu city suffered slight damages on expansion joints although most of the bridges at metropolitan cities remain intact.

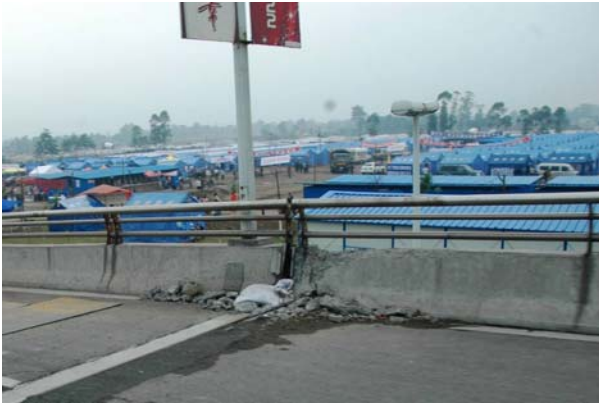
Fig. 32 The damaged expansion joint
